## SCBA Cylinder Inspection Guide Carbon Fiber Composite Cylinders

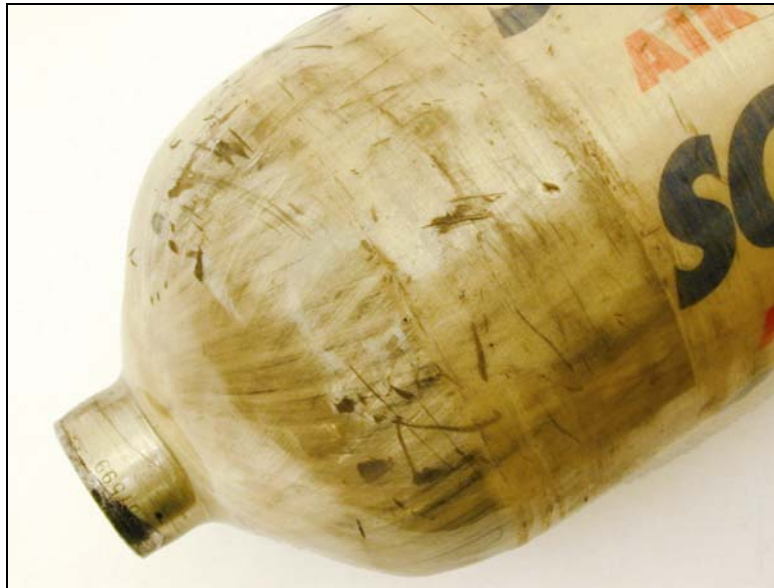
Level 1 damage or defects are identified by scratches or minor damage to the outer coating of the cylinder, the gel coat. The cylinder may also exhibit a slight discoloration of the outer coating, particularly if the cylinder has been exposed to high levels of heat, such as a fire. Typically, the discoloration will be amber or light brown in color. This level damage or defect does not require the cylinder to be removed from service. Slight discoloration of the outer coating does not require removal of the cylinder from service unless the labeling of the cylinder in the gel coat has also turned brown or black, or the labels on the surface of the gel coat are slightly charred. Then the cylinder should be classified Level 2. See the photograph in Figure 2. Areas of the cylinder exhibiting Level 1 damage are to be monitored for possible additional damage.

Figure 2  
Level 1 Damage / Defect (typical)  
Scratches in the outer coating or gel coat of the cylinder.

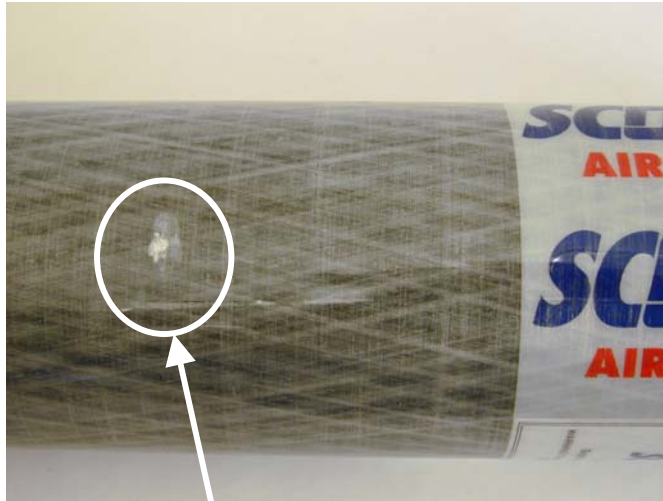
Level 2 damage or defect of the cylinder constitutes damage beyond Level 1, affecting the fiberglass composite layer of the cylinder. This damage will expose the fiberglass composite layer and may further exhibit fraying of the exposed fiberglass composite. See the three photographs in Figure 3. **Cylinders exhibiting Level 2 damage should be removed from service and forwarded to a US Department of Transportation (DOT) authorized hydrostatic testing facility for further inspection or repair.** A listing of the USDOT authorized hydrotesting facilities can be found on their web site: <http://hazmat.dot.gov/ohmforms.htm#hydro>

Level 2 Damage on Side Wall of Cylinder (Highlighted by Circle)

Figure 3  
Level 2 Damage Defect – Penetration of Gel Coat

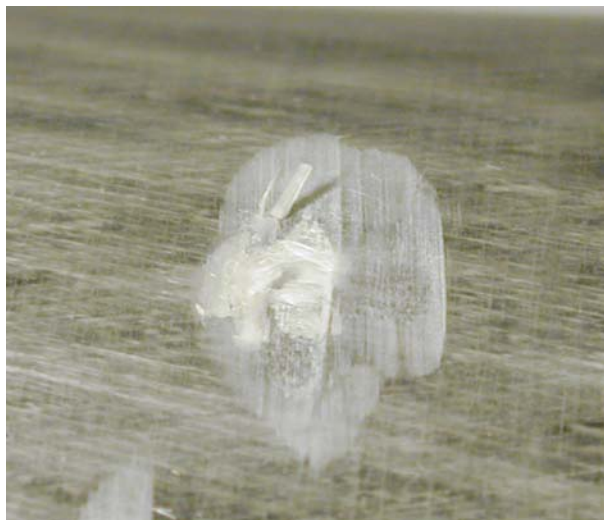
Area in Circle in Above Photo Magnified – Note penetration of Gel Coat (Typical)

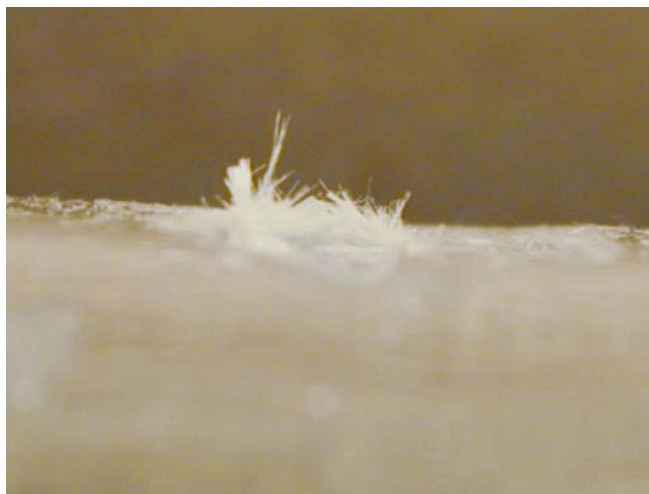
Side View of Damaged Area - Showing Some Fiber Breakage

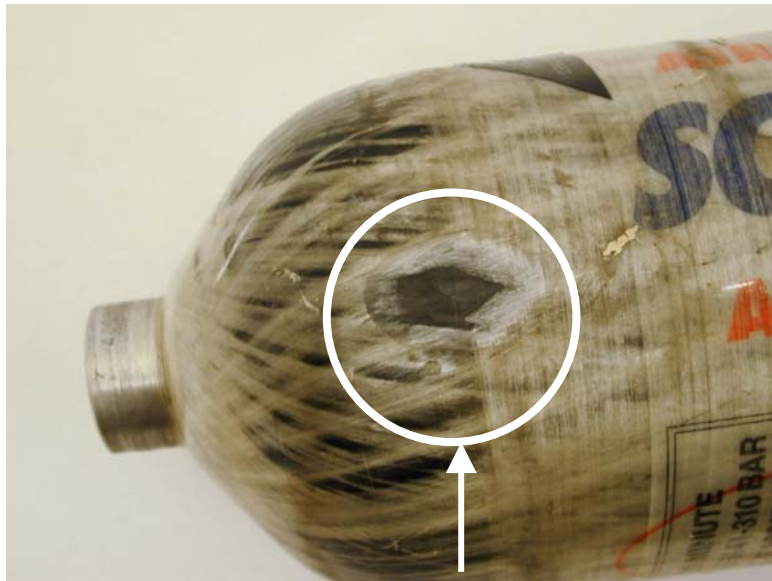
Level 3 damage/defect is typified by exposure of the black carbon composite layer. Level 3 damage can also be identified as severe discoloration of the cylinder with the labeling bubbled and charred due to exposure to high heat. See Figure 4. Frosting of the gel coat or visible breakage of the fibers as seen through the gel coat may mean the cylinder is bent, dented or bulging. This can generally be verified by rolling the cylinder along a hard, flat surface and carefully examining the contact between the cylinder and the surface. Bent, dented or bulging cylinders should be classified as Level 3 Damage / defect. Signs of corrosion or other form of chemical attack can be evidenced by changes in color or surface (ie. bubbling or “melting/dissolving”) or the deposition of a foreign substance. These cylinders should be classified as Level 3 Damage/Defect. **Cylinders exhibiting Level 3 damage should be depressurized of air and removed from service.**

Level 3 Damage on Cylinder Crown – See Area in Circle

Figure 4  
Level 3 Damage / Defect  
Exposure of the Carbon Composite Layer

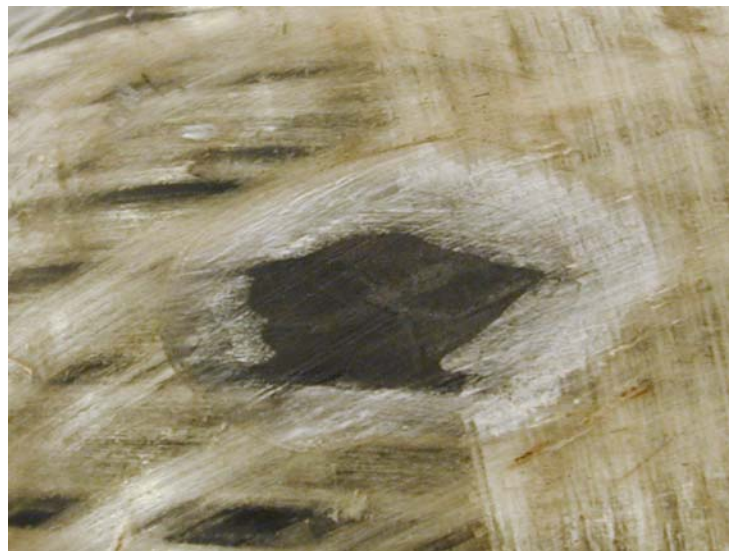
Level 3 Damage Area in Circle Magnified from prior Photo Note Carbon Fiber Exposed
